## Issues & Trends

### **Rust Jacking in the Heavy-Duty Market: Understanding What It Is and What Is Being Done**

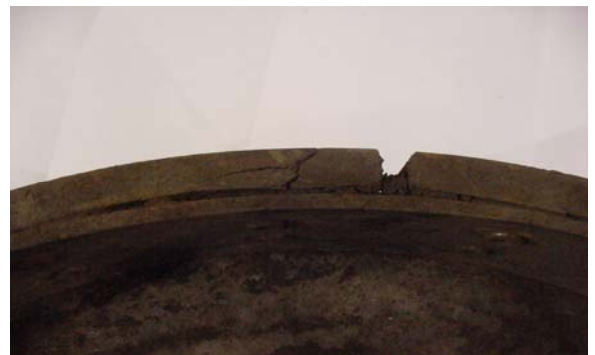
Figure 1

Rust jacking occurs when rust forms on the brake shoe table under the lining causing the lining to lift and crack. In addition, it can cause the shoe to deteriorate. Common industry maintenance practices show that a shoe and lining assembly could be rust jacked if all of the following conditions exist:

- There is at least 1/8" of usable brake lining remaining above the rivet heads (3/8" total lining remaining)
- The lining is lifted off the shoe, resulting in a gap between the shoe table and the bottom of the lining block
- The lining block is cracked along the edge as shown in Fig. 1

The formation of the oxide rust layer is created by corrosive elements and moisture getting under the lining block causing the shoe table to corrode. The formation of this ferrous oxide layer and its growth causes the lining block to be pushed away from the shoe table. Since the rivets hold the block tightly to the table, the result is cracks in the block near the rivets. Several factors influence this process, including: vehicle duty cycle, geographic region of operation, quality of the brake shoe table paint process and other on road chemical compounds.
